SITE INSPECTION REPORT

JOB NO: 14-0083 DATE: 23/02/2016
FILE REF: F7c TIME: 2.00pm
WEATHER: Fine INSPECTOR: Rachel Harmer

PROJECT: Warham Reading Room

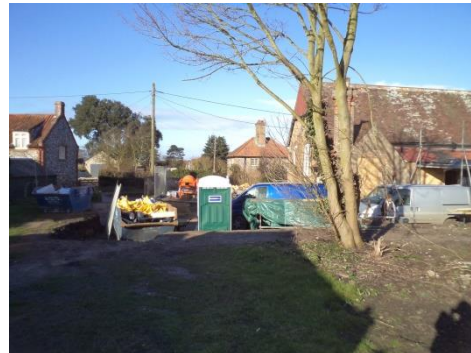
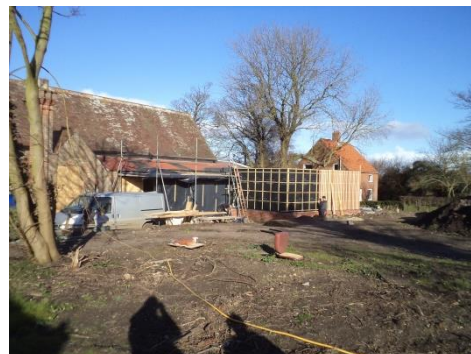
- 1.0 General view of progress to the rear, cladding being installed, awaiting doors and canopy. Forward canopy details upon receipt.

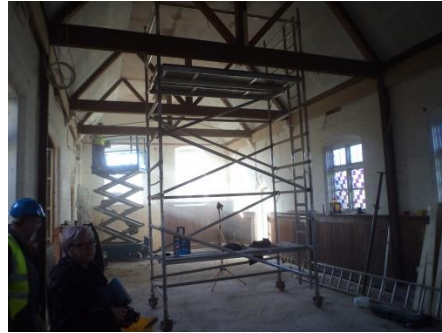
2.0 General view of main hall. Ceiling plasterboard complete. Sanding of timber in progress. Panelling complete with the exception of top trim.

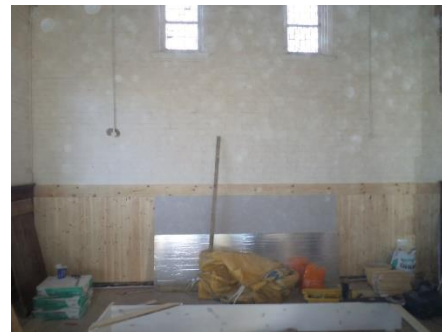
3.0 Plastering in second hall and kitchen complete, screed going down in kitchen

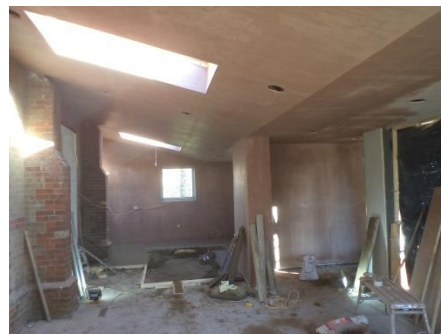
4.0 Screed complete in store, side window installed.

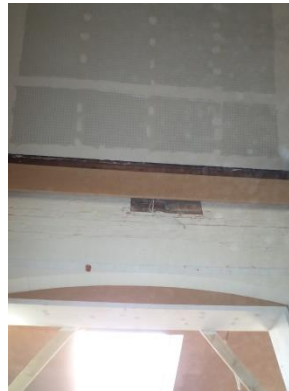
5.0 Timber trim required to cover the junction between ceiling plasterboard edge and existing timber profile. Original vents to be retained, vent casing seem to have been removed.

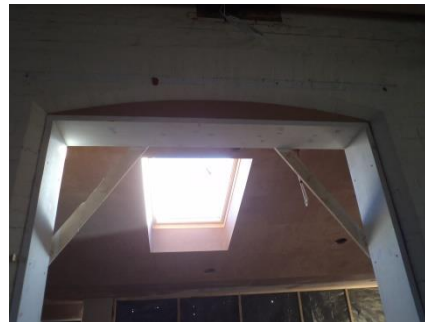
6.0 Door linings being installed.

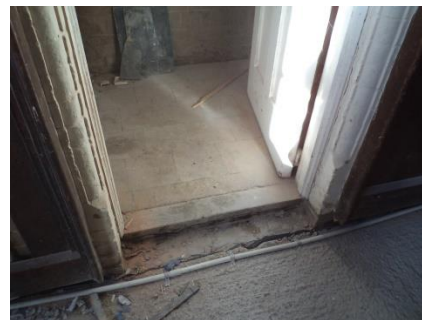
7.0 New timber cil required as existing is rotten.

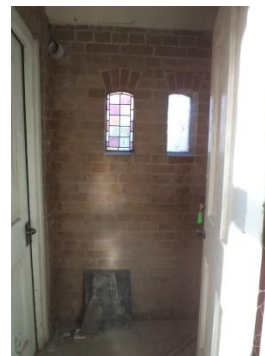
8.0 Existing porch to have walls and ceiling painted as per main hall.

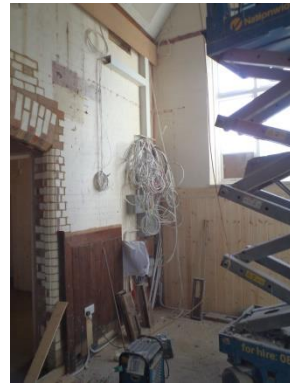
9.0 Awaiting cupboard to conceal services, space to be left at high level within the cupboard for possible pv installation and associated services.

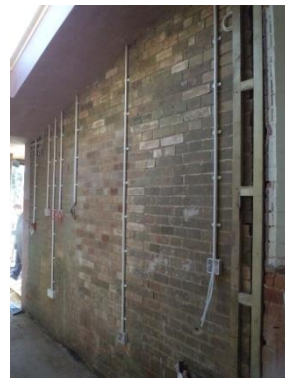
10.0 Due to amount of conduit this wall to be battened out and plasterboard lined, skimmed and decorated.

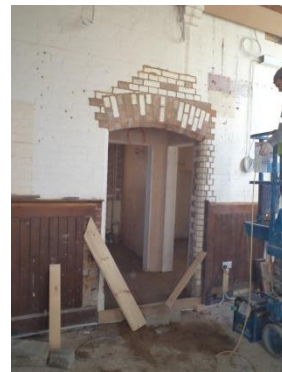
11.0 WC's plastered and screeds completed.

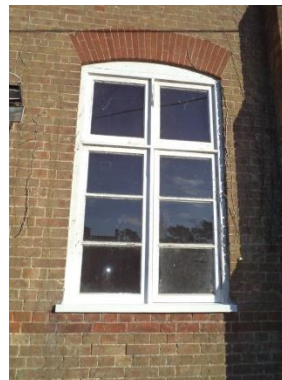
12.0 Timber repairs to windows commenced on west gable.

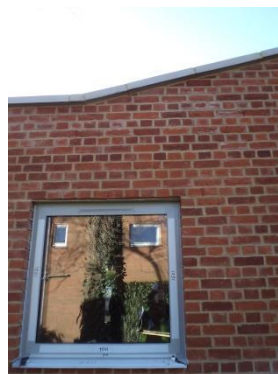
16.0 General view of kitchen window within brickwork and coping over. Tidy pointing to reveals and seal to soffit.

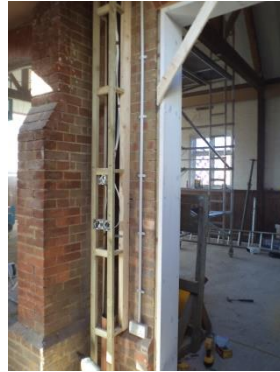
17.0 Socket to be moved and incorporated into boxing to prevent

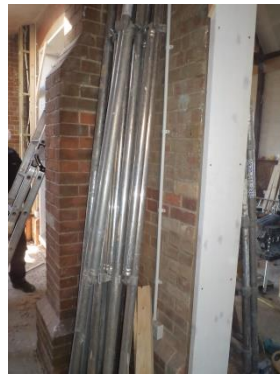
18.0 Omit socket and conduit, it was agreed socket provision was adequate without this and visually it would improve with out it.

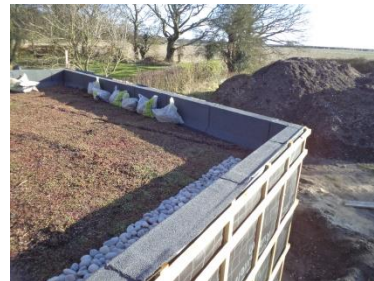
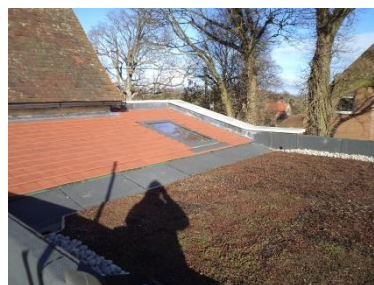
19.0 Details of the green roof system used to be forwarded. Gravel boarder in progress. Awaiting ppc cappings. Leaf guard and hopper to be installed as per 14-0083 2502 D-10. RWO to have balloon cages.

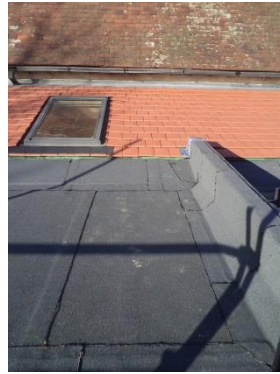
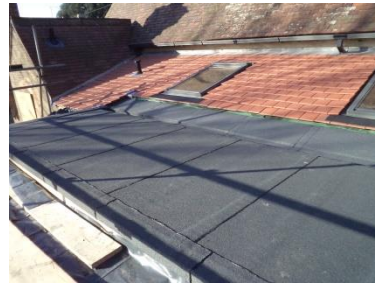
20.0 General photos of new flat roof, tiled lean to and repaired existing roof.

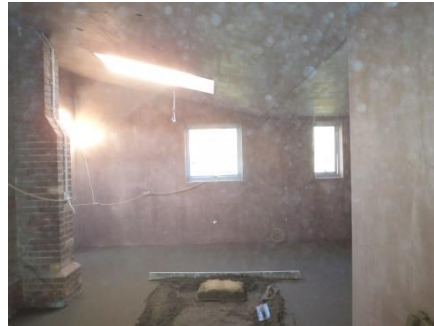
21.0 Alter conduit route so it doesn't follow contour of pier and is located discretely kitchen side of pier and comes discretely into the socket from the side.
